# Sliplining Parktown's ageing water pipeline infrastructure

Subsurface pipeline construction and rehabilitation company Trenchless Technologies recently completed a 12-week contract for specialist contractor Con-Solve Civils and MPA Consulting Engineers.

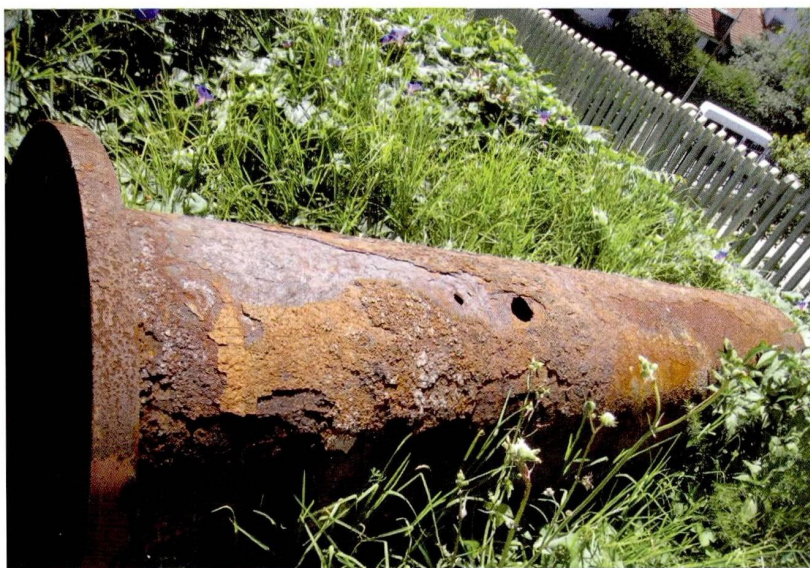
**LEFT** Sample of a removed corroded section of 600 mm steel pipe

commencement of the project, we conducted closed-circuit television (CCTV) investigations on the pipeline to determine its condition and look for obstructions. The investigations determined that the pipelines were badly corroded and pitted, and in dire need of refurbishment. It was also discovered that the pipeline lay at

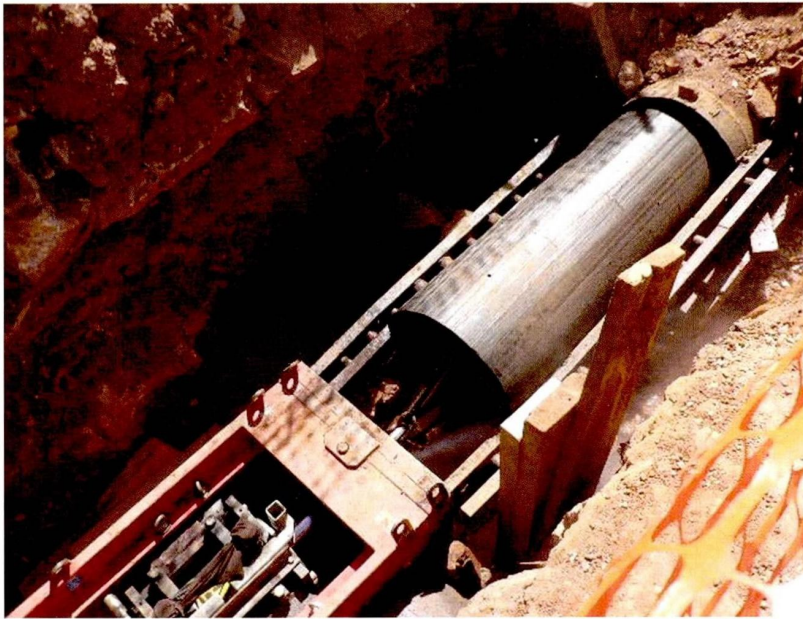
**LEFT** Completion of sliplining line 1 using 60 t rod puller

any obstructions, it commenced the sliplining works. Four sliplining sections were undertaken in total. Additional works included installation of new 600 mm diameter fabricated tees, bends, spool pieces and valves. The contract was completed by the company in less than 12 weeks.

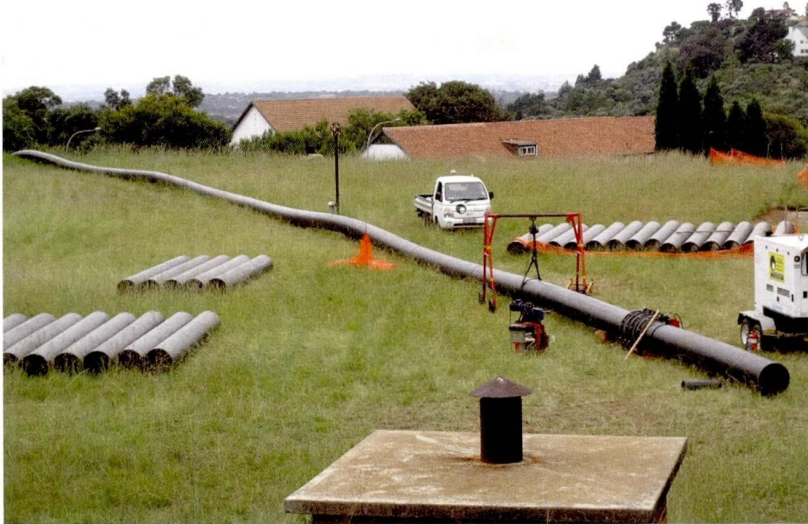
**ABOVE** Butt-welding of 560 HDPE pipe in preparation of sliplining

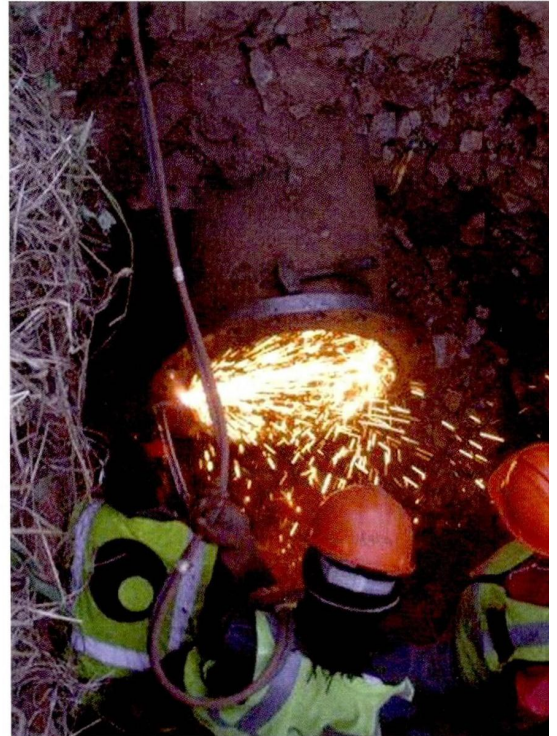
**RIGHT** Welding New 600 Flange to allow tie-in for nine-hour shutdown

to lay a steel pipeline underneath the access road to Reservoir No 1, just below Reservoir No 2. Here Trenchless Technologies excavated across the road, layed the steel piping and connected it to a new steel tee piece at one

end and onto an existing 600 mm diameter flanged gate valve at the other end. The road was reinstated in just 24 hours. **35**
