Pipe dream

In December *Metrobuild* visited a Trenchless Technologies pipe repair site in Pretoria to see at first-hand their installation of a RibLoc Expanda Pipe system. Trenchless Technologies operate the RibLoc process under licence from RibLoc Australia. This installation was the final stage of a R2 million RibLoc section, completing an overall contractual value of R23 million of pipe repair for the City of Tshwane. The entire project has been under way for three years, during which time the company has some 40 000 m of piping has been repaired.

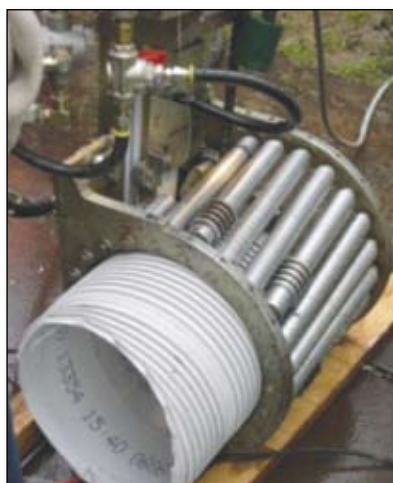
Winding cage mechanism

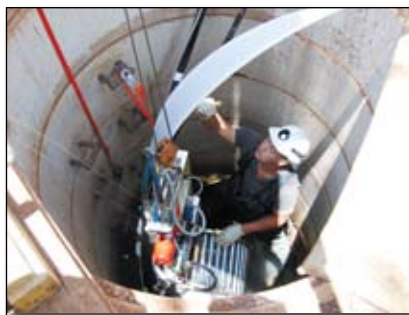
Ribbon profile being fed into the winding unit

The winding machine is placed at the base of the access chamber. Profile is then fed into the winding machine from

the above-ground spool. The machine interlocks the edges of the strip as it spirally winds to form a continuous liner

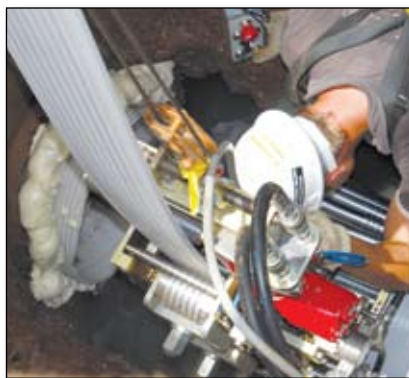
Formed pipe being progressively fed to the right, into existing concrete pipe. Note previously completed section on the left

lock, and a wire is simultaneously inserted between the locks as the profile is interlocked. The liner then expands in diameter to fit tightly against the inside wall of the deteriorated pipe. A CCTV camera in the liner monitors progress of expansion for the above ground operator.

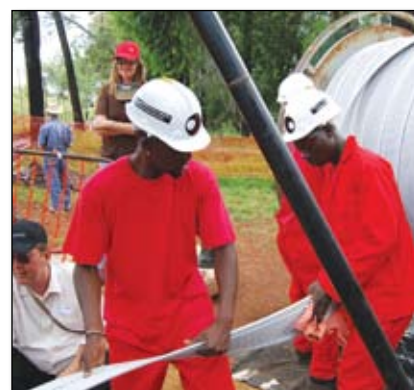
Topside ribbon profile spool
